CHECK YOUR HITCH RECEIVER!

Russell Decker, WBCCI #3426

January 2019

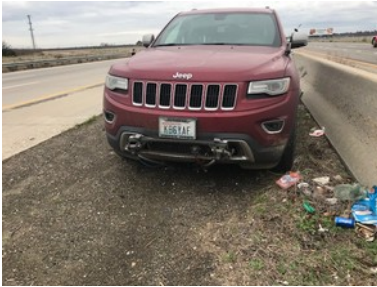
This is how I found my Jeep when I traveled back over 25 miles. It's as if someone parked it there on purpose. Notice that all of the tow bits are under the jeep which punctured the tranny pan and messed up the internal parts that eventually required a complete new tranny to be installed.

What really made me cry was my nice Diamond dual band ham radio antenna broke!!!

I did have to leave the jeep at the Gill Auto Group in Madera for over 3 weeks for all the repairs which included some body and paint, a new tranny, plus a new 2m/70cm ham radio antenna! I did make it to Quartzfest in Arizona, then my week after that in Tucson before returning back to Visalia.

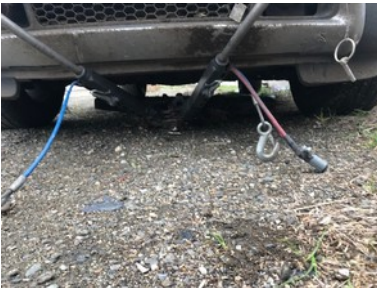
The entire tow bar assembly was still connected to the hitch receiver that ended up under the jeep that most likely happened when the jeep hit the 'jersey rail' in the center median. That's when a lot of the damage happened to the underside requiring a replacement of the dented oil pan and an entire new transmission.

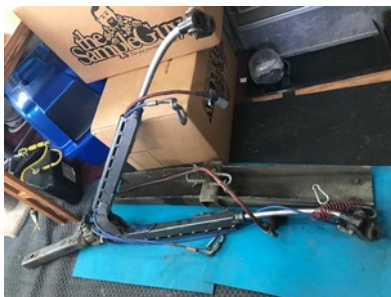
Here is a photo of the RoadMaster towbar assembly. Those hardened stainless steel bars are suppose to be straight to articulate in and out smoothly. You can also see the underside of the hitch receiver which should be welded on to the back of the motor home.

Tow Bar replacement...\$ 1,000+. Insurance covered this.

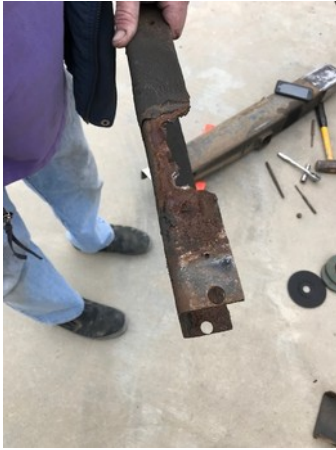
ran back across the southbound lanes of traffic back to the motor home to get a big hammer and my 1/2" socket extension bar to beat the tow pins off of the jeep's tow connection point. I ran back to the jeep, and after about 15 minutes, had both tow pins removed and dragged the tow bar assembly out from under the jeep. Both tow bars were bent around 45° but were intact and still connected to the hitch as were the safety cables, electrical cable and break-away cable. Upon inspecting the motor home's hitch receiver that was under the jeep, I noticed that both weld points had failed, no doubt due to metal fatigue.

Here is a photo of one side of the hitch receiver mount where the hitch receiver cross member was supposed to be welded to it. It had ripped away.

While in Visalia, I contacted an RV hitch specialist that not only welded my hitch receiver back on, but added a LOT of extra flat iron and angle iron to it so that I will never have to again experience a hitch failure. He was very kind to me and kept the price of the hitch fix under \$450. The replacement tow bar parts came to just a little over \$1,000. I can say that all the tow parts held up quite well, so I highly endorse the Roadmaster Inc. Falcon tow hitch! Oh, and did I mention that they had all of the replacement tow parts shipped to Visalia within 3 days with NO shipping charges? A big 'high five' to them.

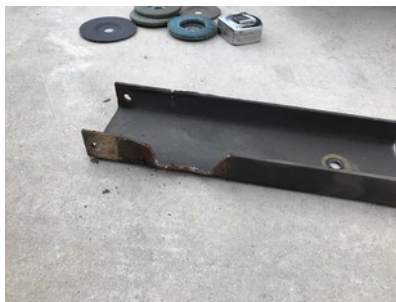
This is the other side of the hitch mounting rail. The bent parts were cut out and two pieces of 3" x 1/4" flat steel were going to be welded both on top and on bottom of the length of the mounting rail to provide a heavier, and much added support of the hitch receiver.
